HISTORIC STRUCTURE REPORT

Thomas H. Moore House
2201 Dixie Avenue SE, Cobb County
Smyrna, Georgia 30080-1578

Prepared for: Joel Powell, Property Owner
Prepared by: Conservation of Historic Building Materials Class
Georgia State University, Fall 2013

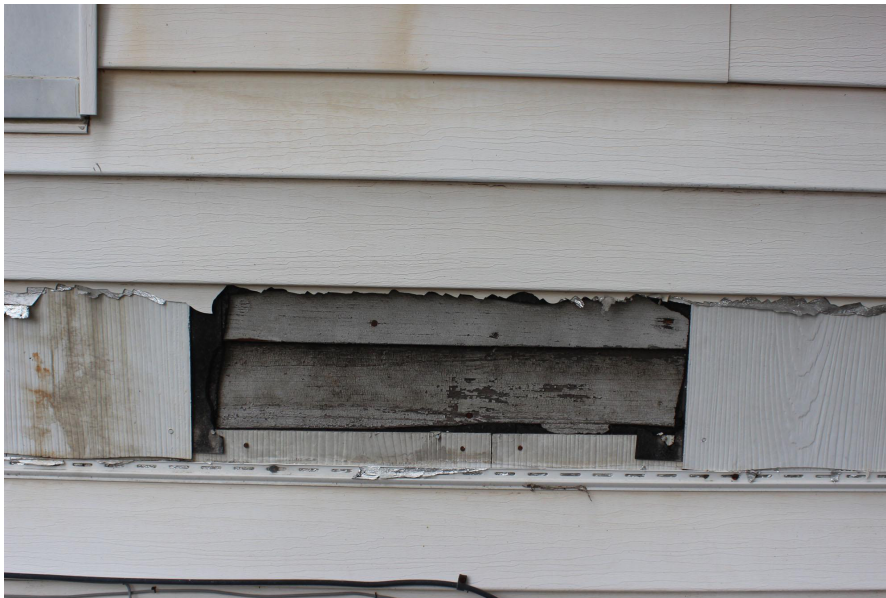
The home is vernacular in style with some classical details such as the ionic columned, west-facing porch. The exterior siding has at least four layers beginning with what appears to be the original wood clapboard with four to five layers of paint covered by tarpaper, then asbestos, and finally the current outer layer of white vinyl siding (Figure 3.16).

Figure 3.16: Exterior layers of the south facade siding.

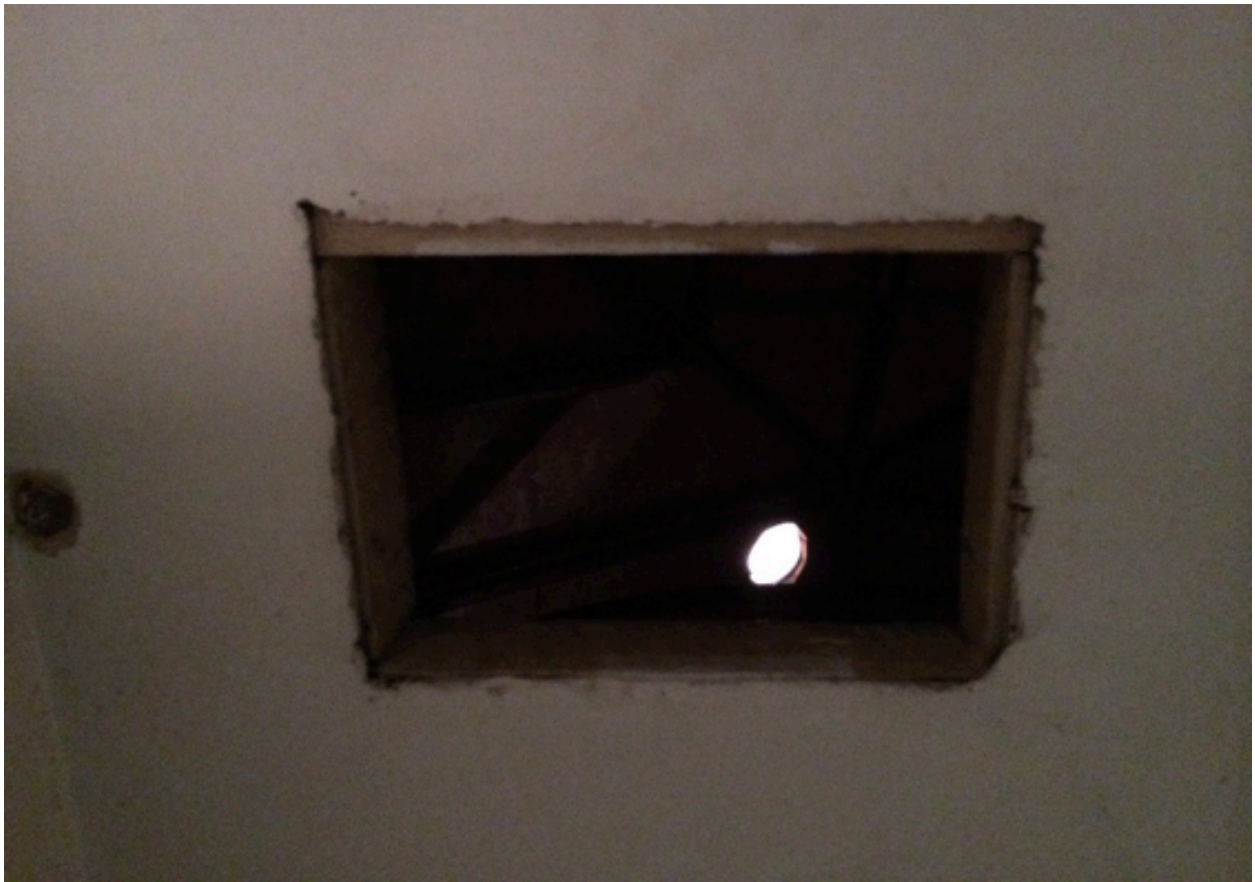
Figure 3.27: Informal cut out in ceiling of room 208 provides access to the attic.

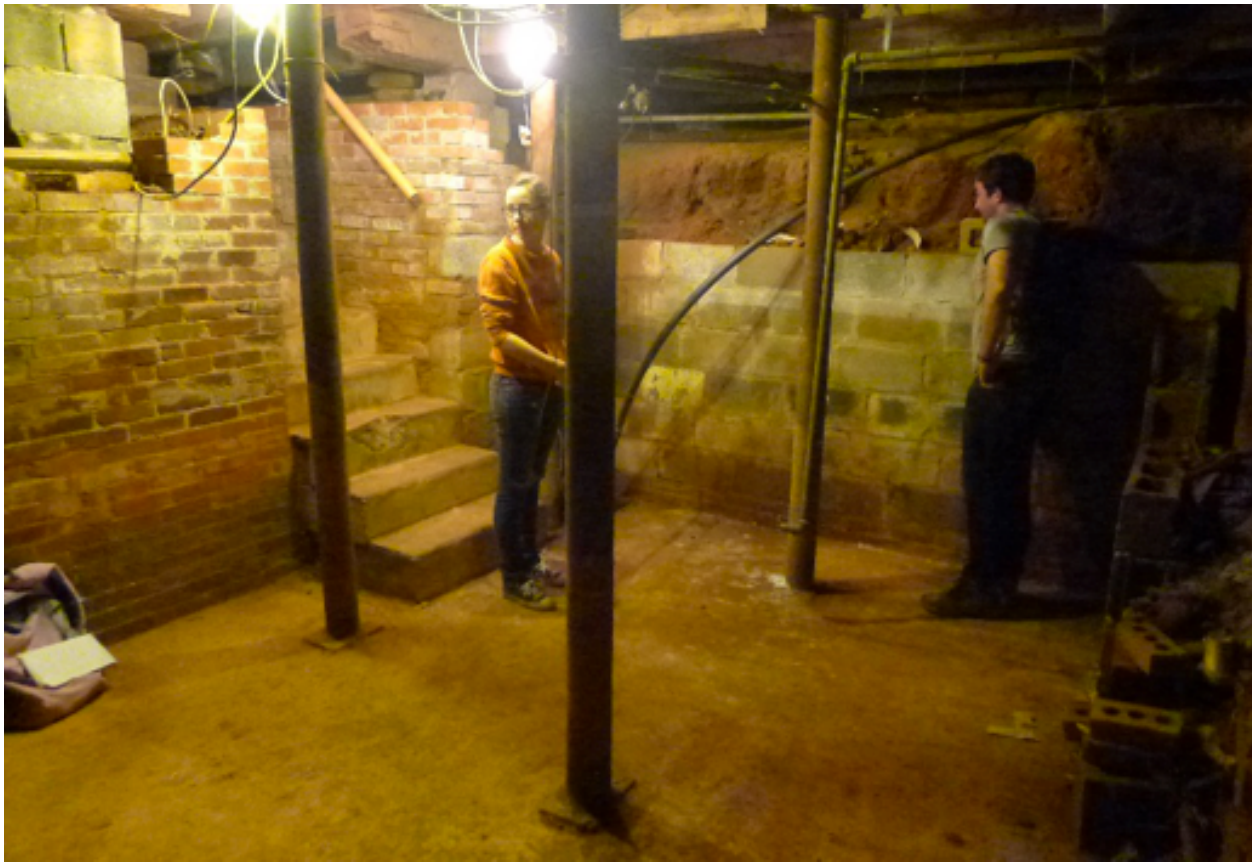
Figure 3.44: Metal posts within dugout create support in place of brick piers.

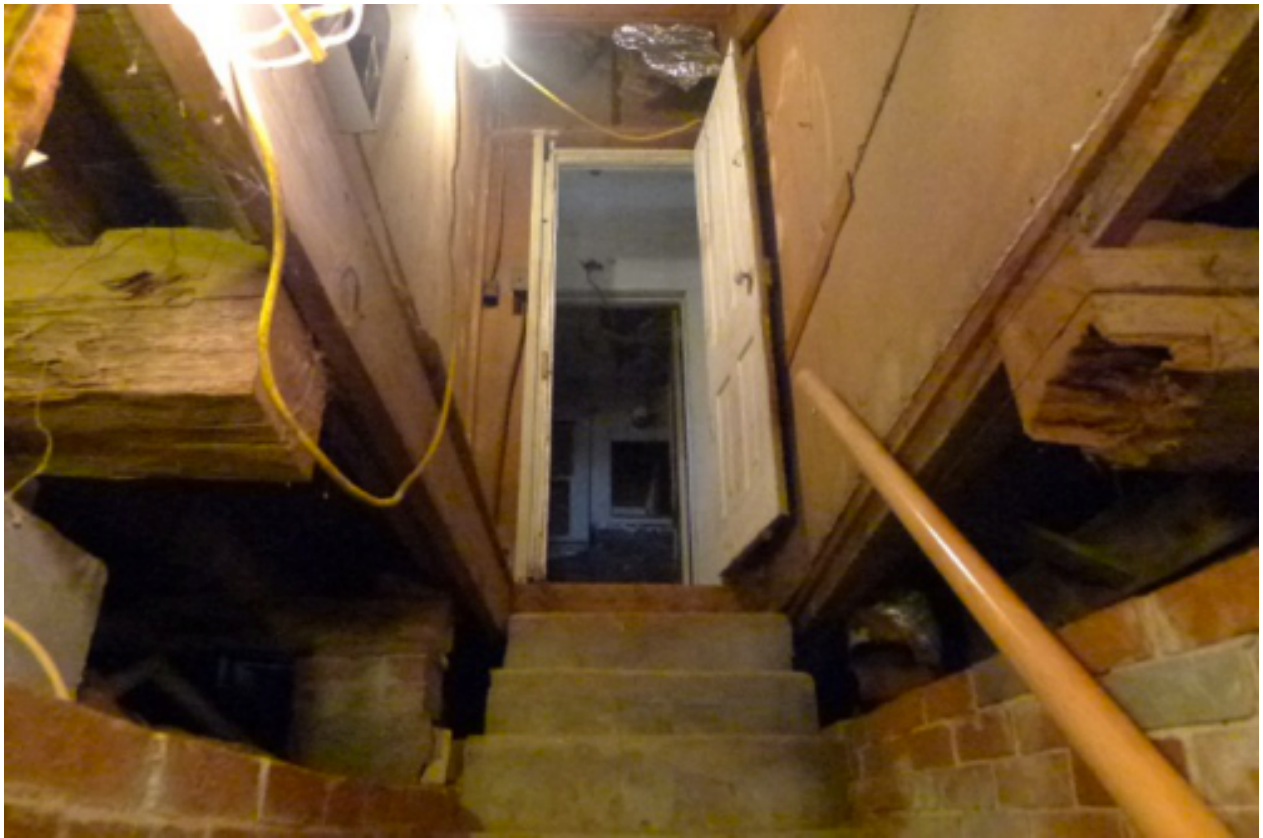
Two new cinder-block piers were installed on either side of the staircase to continue supporting an original timber spanning across the space that was cut through in order to construct the staircase (Figure 3.45). Other timbers were cut to allow space for HVAC systems and duct work. A number of make shift support systems were constructed to make up for shifting load bearing supports when the space was dug out. These include plywood shims into uneven crevasses, and the use of stones to balance shifting and crumbling piers affected by the changes to the foundation (Figure 3.46).

Figure 3.45: Original hand-hewn timber cut to make room for concrete staircase.

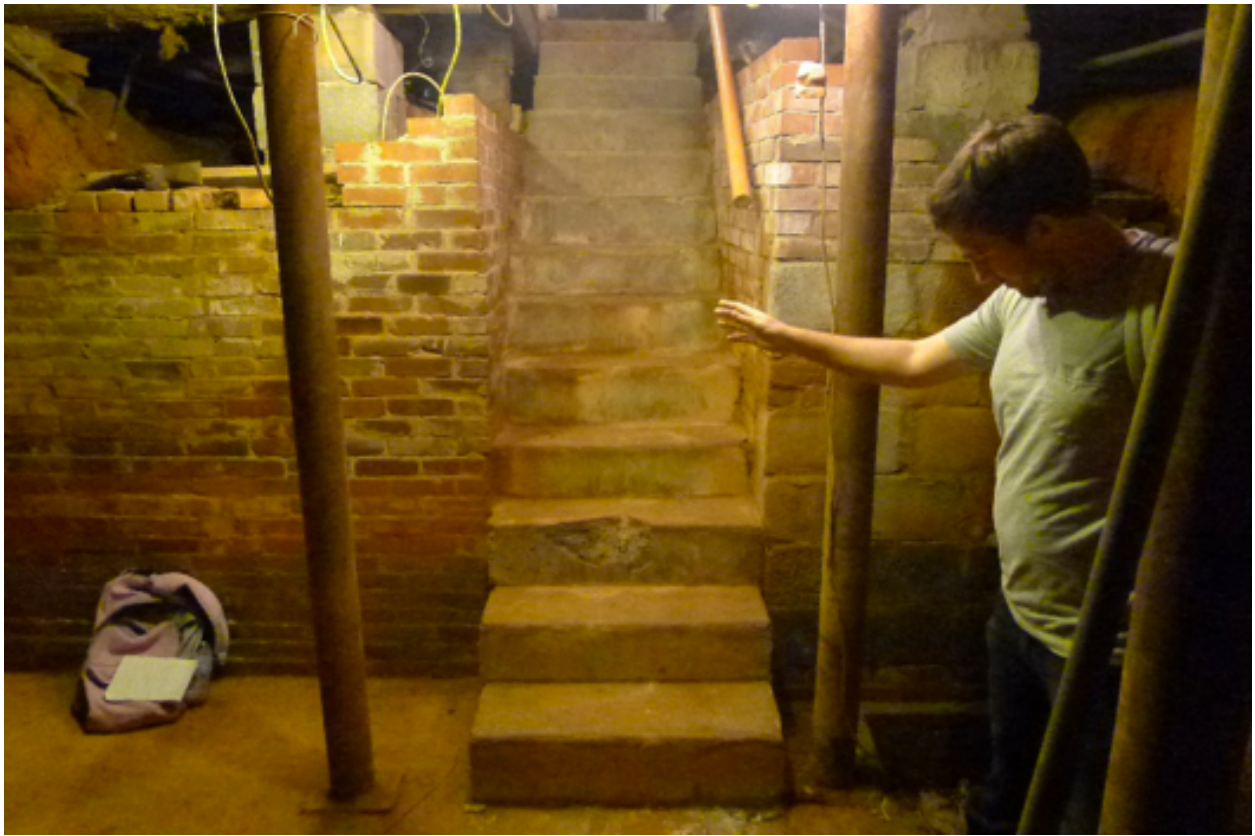
The borders of the dugout have been lined with brick and concrete block to reinforce the standing dirt foundations. These barrier walls help to keep the dirt from crumbling or collapsing into the cleared, open space. The brick wall lines the east and part of the north side of the dugout (Figure 3.47). The cinderblock wall lines the south and part of the west side of the dugout (refer back to Figure 3.44). A small portion of the north and west side of the dugout is not reinforced with brick or cinderblock walls and leaves the dirt foundation exposed (Figure 3.48). The exposed foundation still has the tool marks left by the digging out process (Figure 3.49).

Figure 3.47: Brick reinforcement wall along east side of dugout.

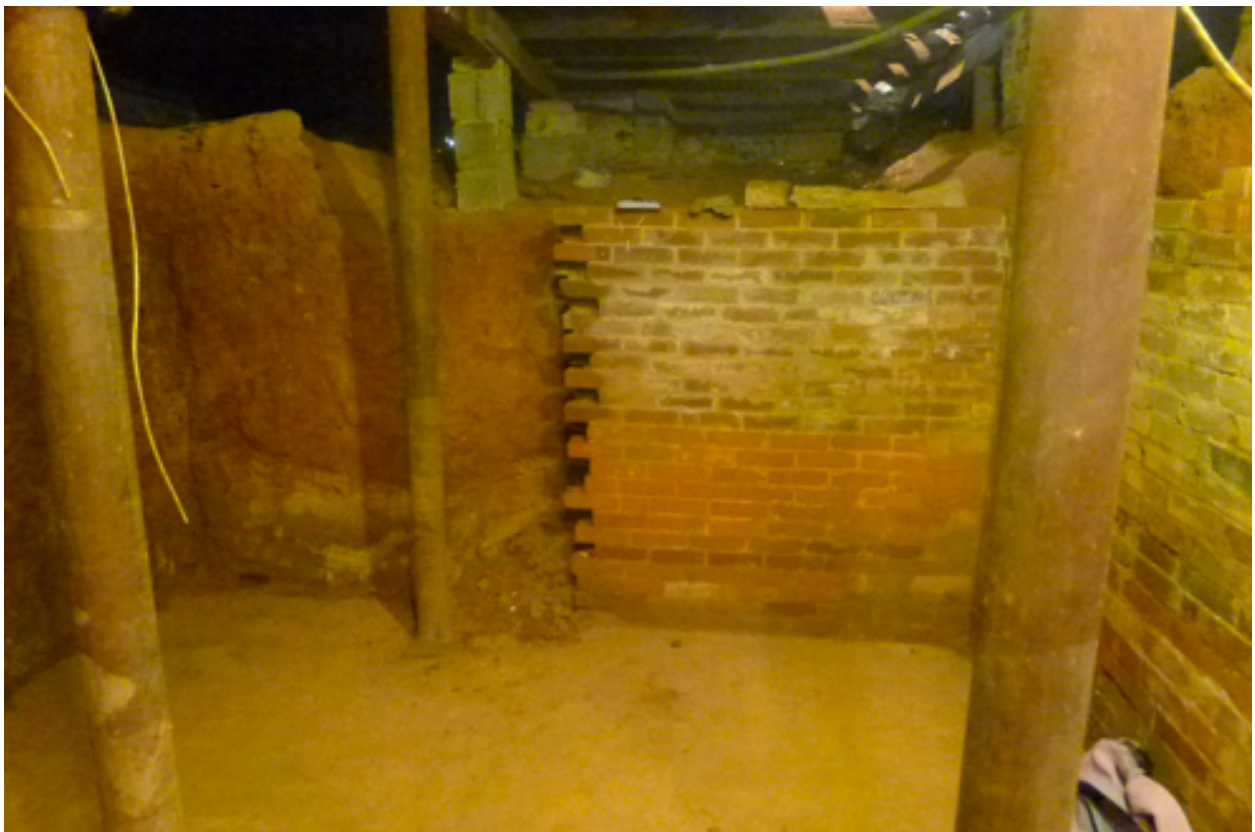
Figure 3.48: Brick reinforcement wall along part of north side of the dugout.

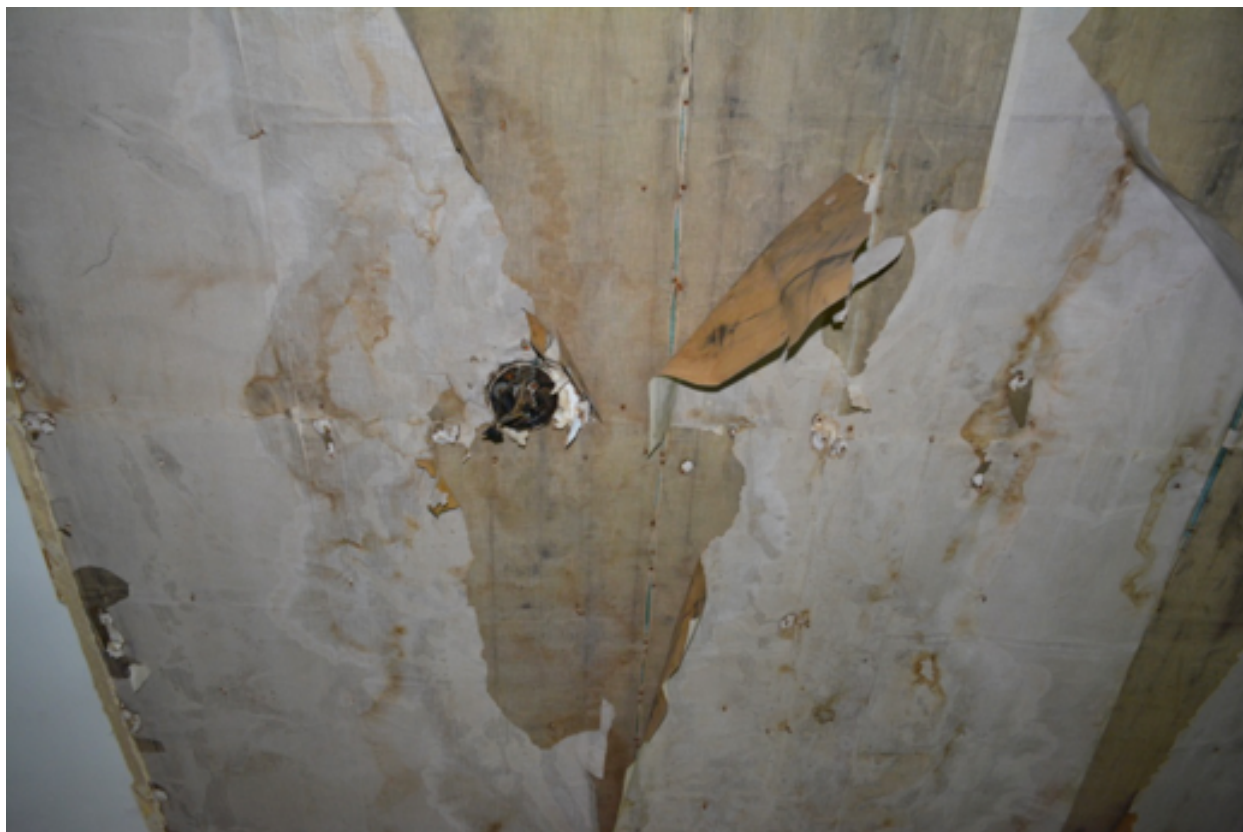
The ceiling has two layers, one of gypsum board and a historic-wood ceiling. The historic ceiling height to the floor is 9'-7"; the gypsum board ceiling height to the floor is 9'-6-1/2". The historic wood ceiling boards measure 3" across and run from east to west. Three quarters of the gypsum board was torn off exposing the original ceiling covered in peeling paper. This muslin tacked to the ceiling paper has evidence of a mica-painted grass cloth pattern. Water damage has deteriorated more than half of the wallpaper pattern (Figure 3.61).

Figure 3.61: Evidence of tacked muslin to ceiling and deterioration of wallpaper.

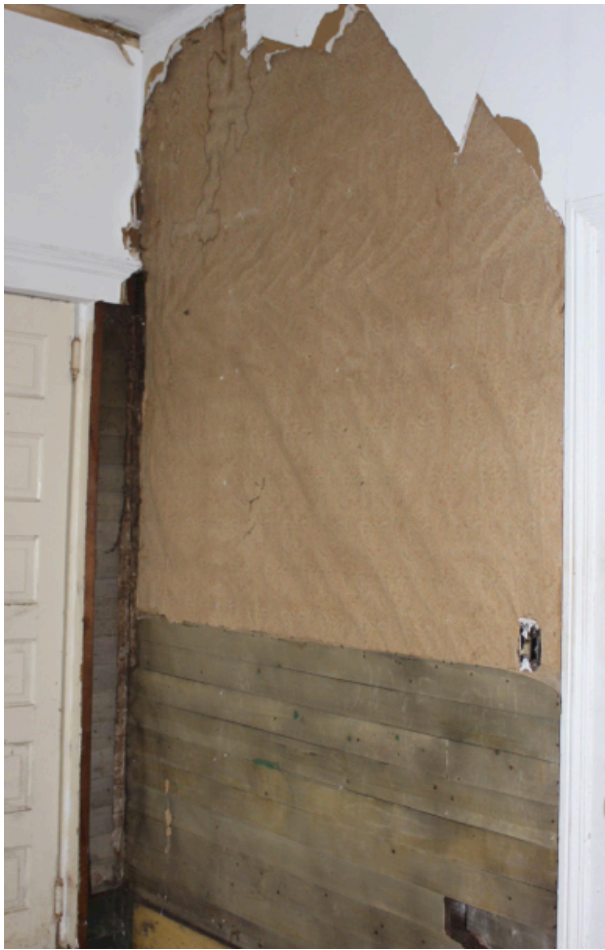
Analysis on the south wall reveals four layers of wall coverings. Underneath the top outer layer of gypsum board is a tacked-muslin, multi-colored foliate scroll patterned wallpaper matching the wallpaper found in Room 101 (Figure 3.62). This paper would have tied Rooms 101 and 102 aesthetically together after the construction of the I-house addition. Prior to this layer of wall covering the walls in room 102 were covered in a wallpaper of cream and white swirls with mica decoration dating to the 1850s (Figure 3.63). This paper was tacked to tongue-and-groove boards

Figure 3.62: Room 102 south wall wallpaper analysis uncovered multi-colored foliate scroll patterned wallpaper matching Room 101.

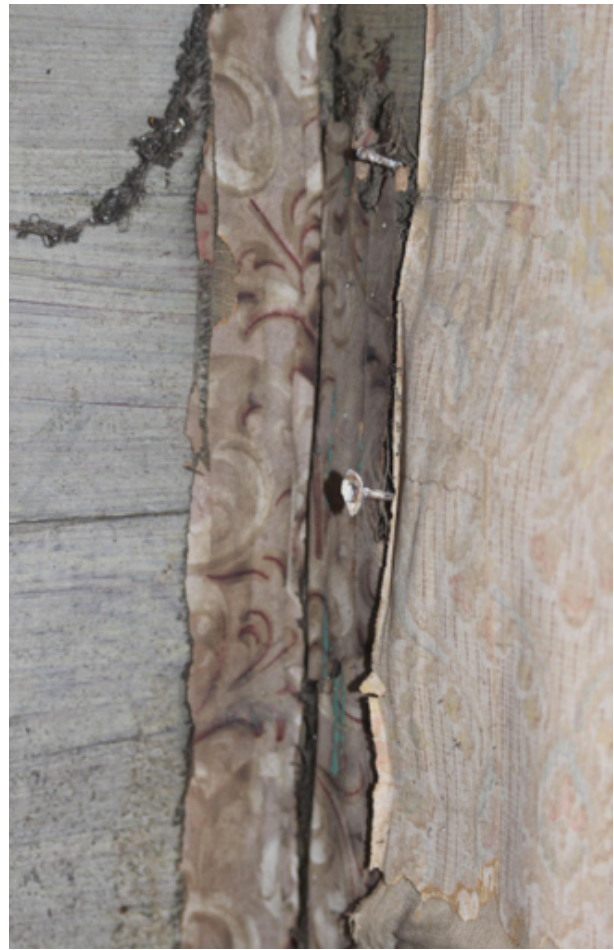
Figure 3.63: 1850s scroll patterned mica decorated wallpaper predating multi-colored foliate scroll patterned wallpaper found in Rooms 101 and 102.

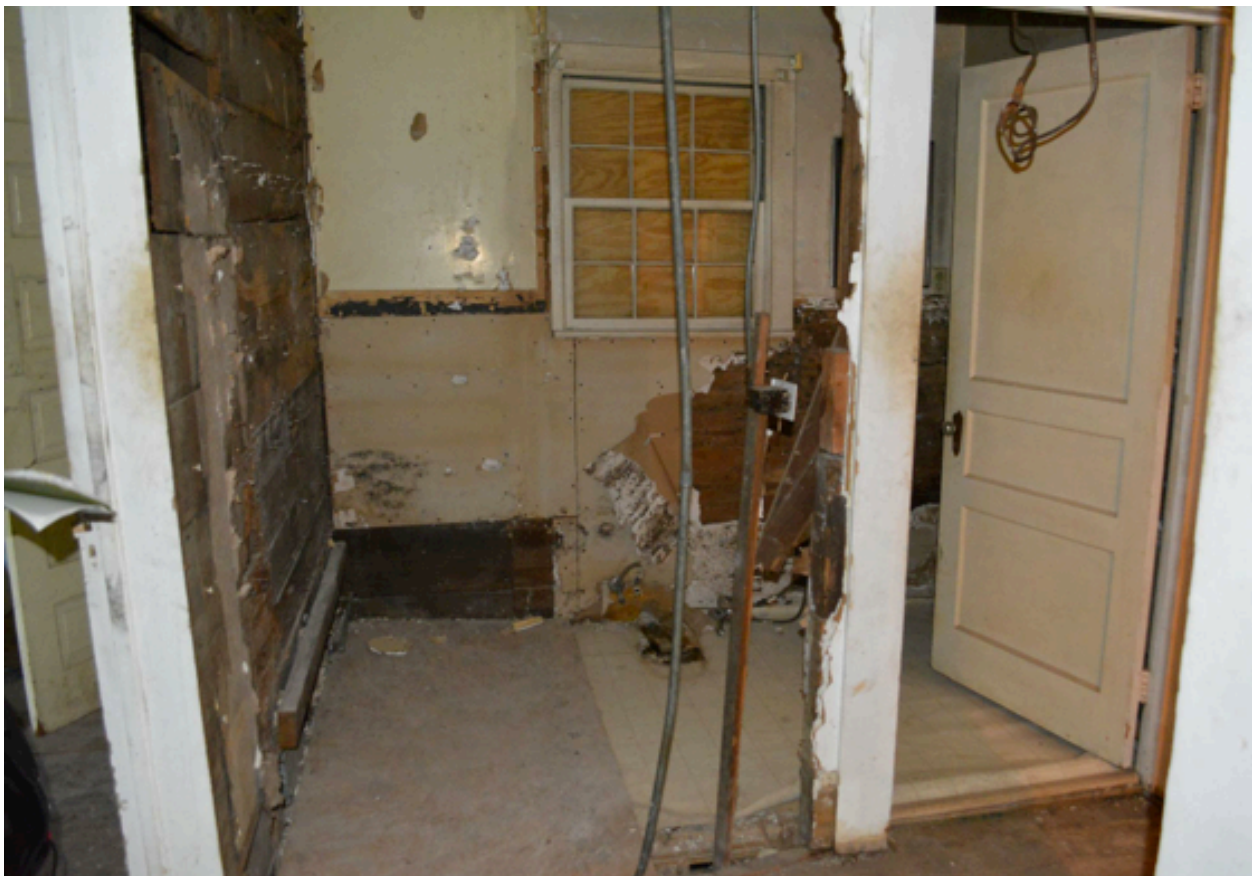
Room 105 had its west-facing hallway wall torn out, exposing the room to the rest of the house (Figure 3.72). A quarter of the north side floors are remnants of historic pine and are partially covered in plywood boards, while the floors on the remaining three quarters is rolled vinyl flooring (Figure 3.70). Even though the walls facing the hallway were torn down, there is still a door frame and a door intact.

Figure 3.72: Room 105 north and east walls looking through Room 104.

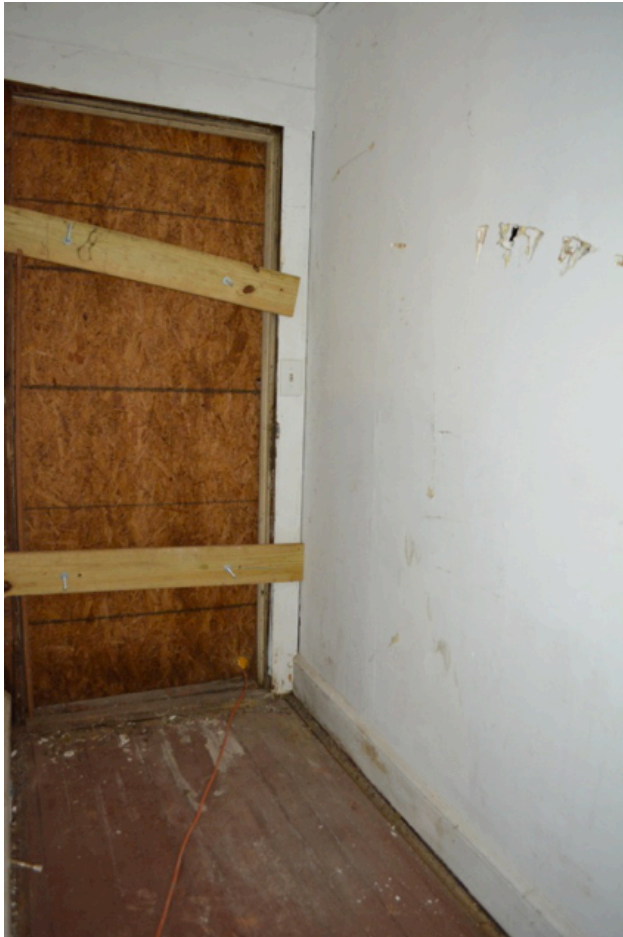
Room 106 is a hallway that leads to a boarded-up door that once led to the garage, room 111, (Figure 3.73). The ceilings are 7'-10-1/16". The walls are made of drywall. The floors are historic pine, tongue-and-groove (Appendix B, Floor Plan).

Figure 3.73: Room 106 east wall boarded-up door leading to garage, Room 111

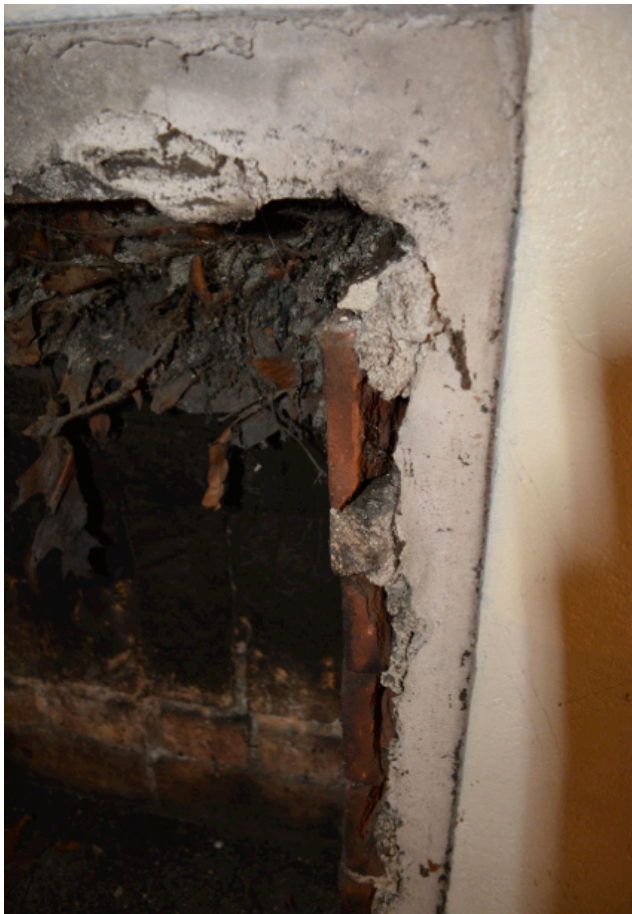
The fireplace is nearly flush with the southern windows. The mantel is a Classical Revival style measuring 5'-¼" across (Figure 3.80). It is detailed with egg-and-dart and various decorative detailed molding (Figure 3.81). Such attention to detail would suggest this mantel to be in a room of significance or to entertain guests. The brick fireplace is shallow and is constructed of historic-brick, patched with Portland-cement-based mortar (Figure 3.82). This is causing the historic, lime-based brick to separate from the mortar due to Portland cement's rigidity. It does not allow the brick to expand and contract naturally, causing it to separate and eventually fall out, causing the loss of historic-brick material.

Figure 3.82: Classical revival fireplace bricks patched with Portland-cement-based mortar.

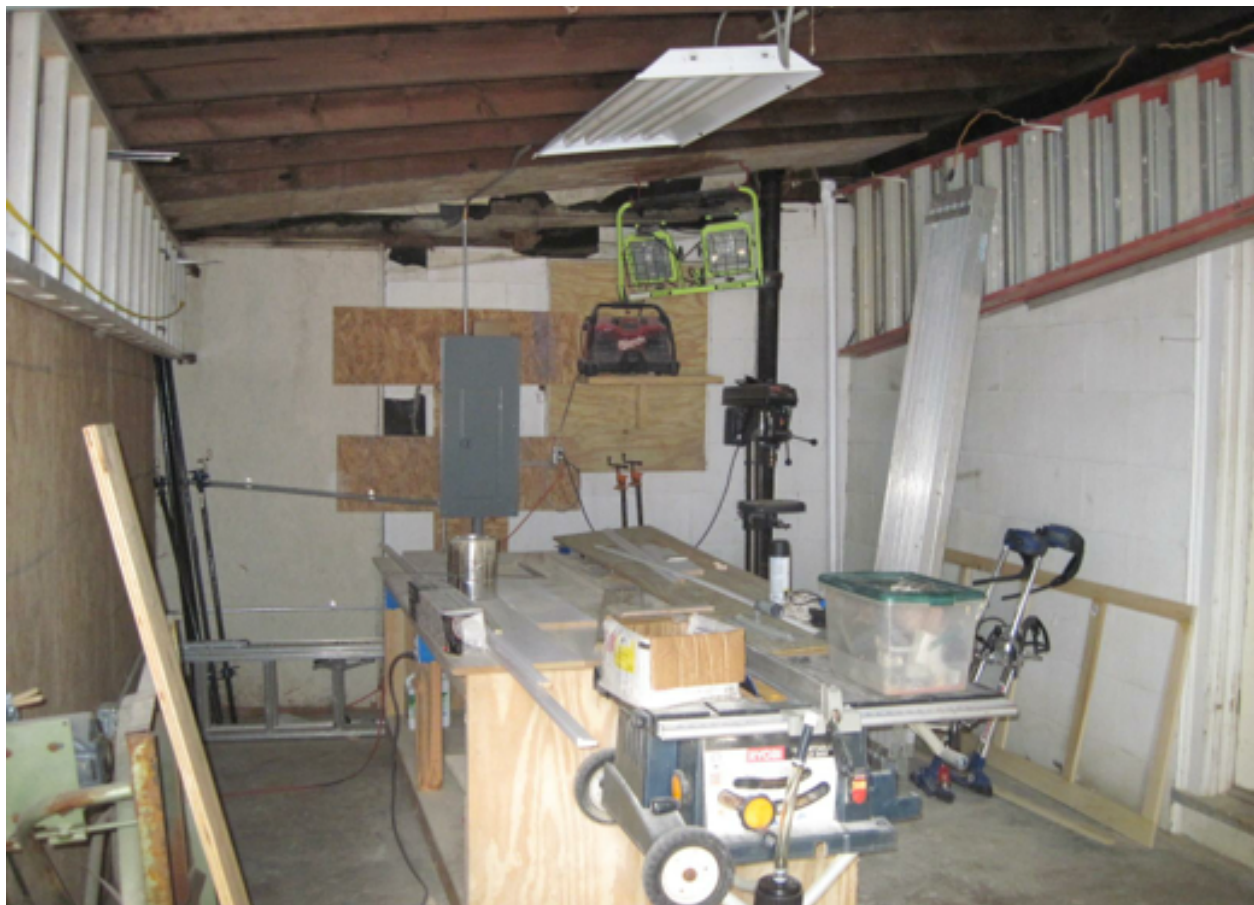
Figure 3.90: Room 110 west wall with boarded-up window to former bathroom, room 105.

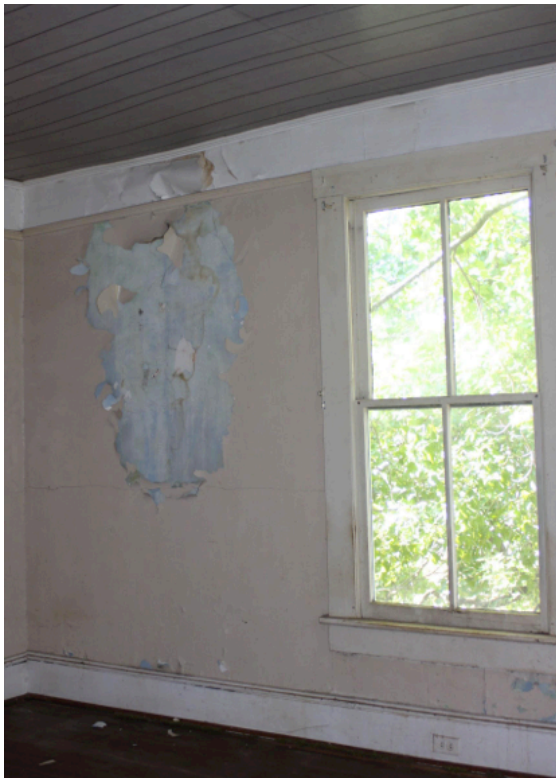
Figure 3.94: West wall showing paneled ceiling and colonial molding, as well as moisture damage.

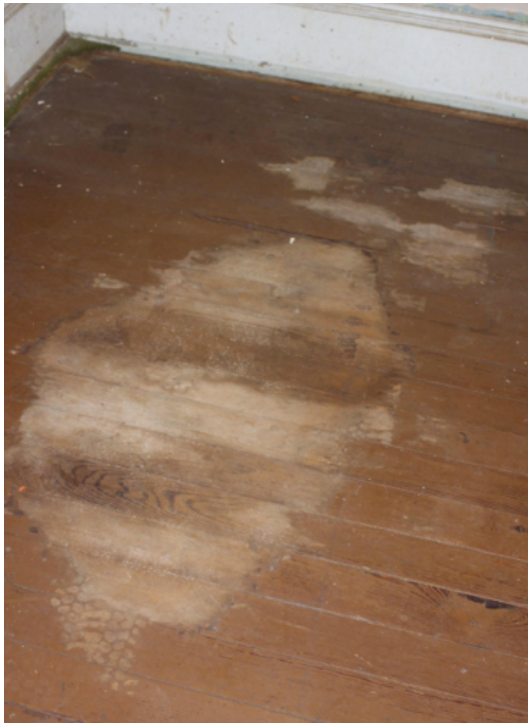
Figure 3.96: Pine, tongue-and-groove floor boards showing evidence of brown staining.

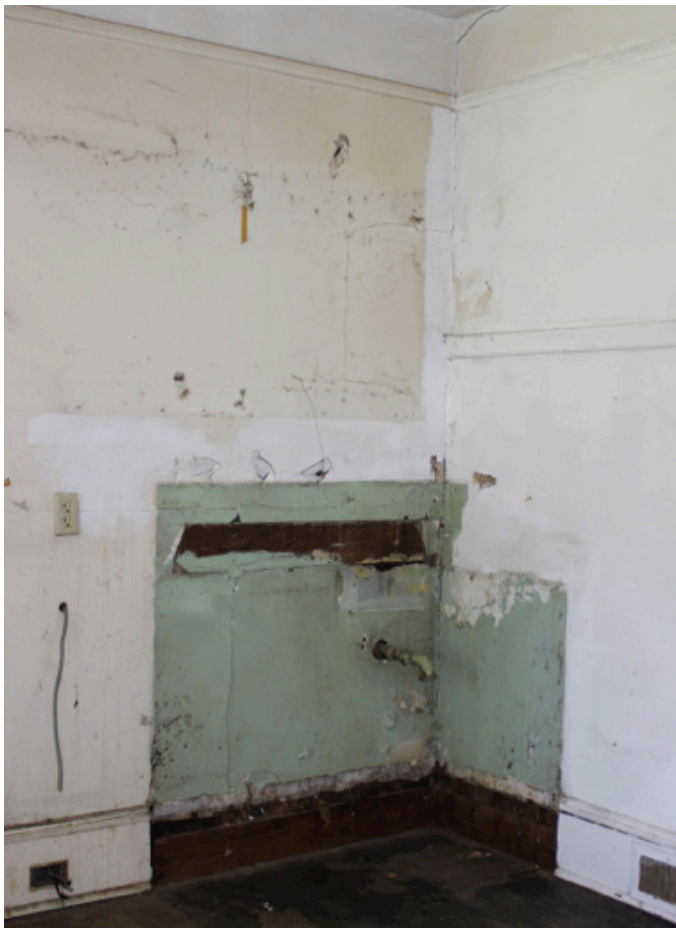
Figure 3.97: Southeast corner of Room 202 showing water line for possible kitchen or kitchenette. Additionally, damage caused by removal of fixtures can be seen.

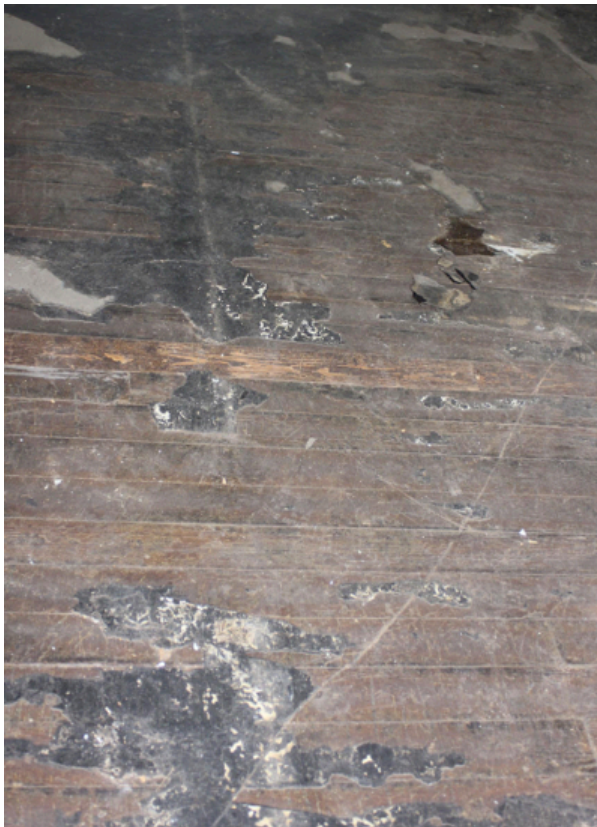
Figure 3.98: Room 202 flooring showing residue.

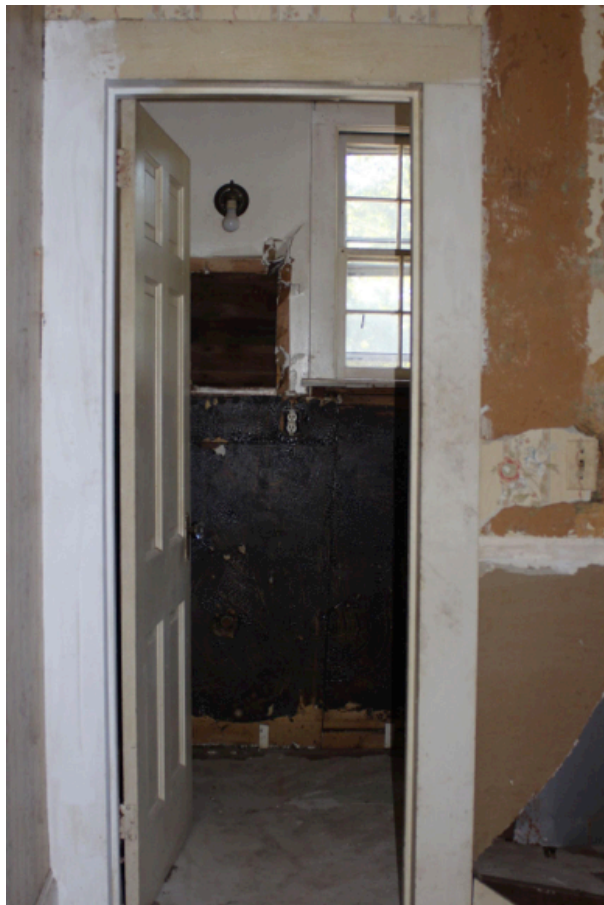
Room 203 is the central of the eastern room by access from the upstairs hall. This rectangular room (Appendix B, Floor Plans) is in poor condition since it has been gutted and no useable fixtures remain (Figure 3.103). The floor is composed of oriented strand board (OSB), plywood, and modern-cut boards, which may be covering older layers of flooring. The walls are also a mixture of OSB, plywood and modern boards secured with machine-made, wire, nails (Figure 3.104). There appears to be some heat damage to portions of the north and west wall covering, which is made from an unknown material. The only natural light source is a 36" x 30" six-over-six, double-hung, window on the east wall (Appendix E).

Figure 3.103: Room 203 facing east from Room 204, toward Room 203.

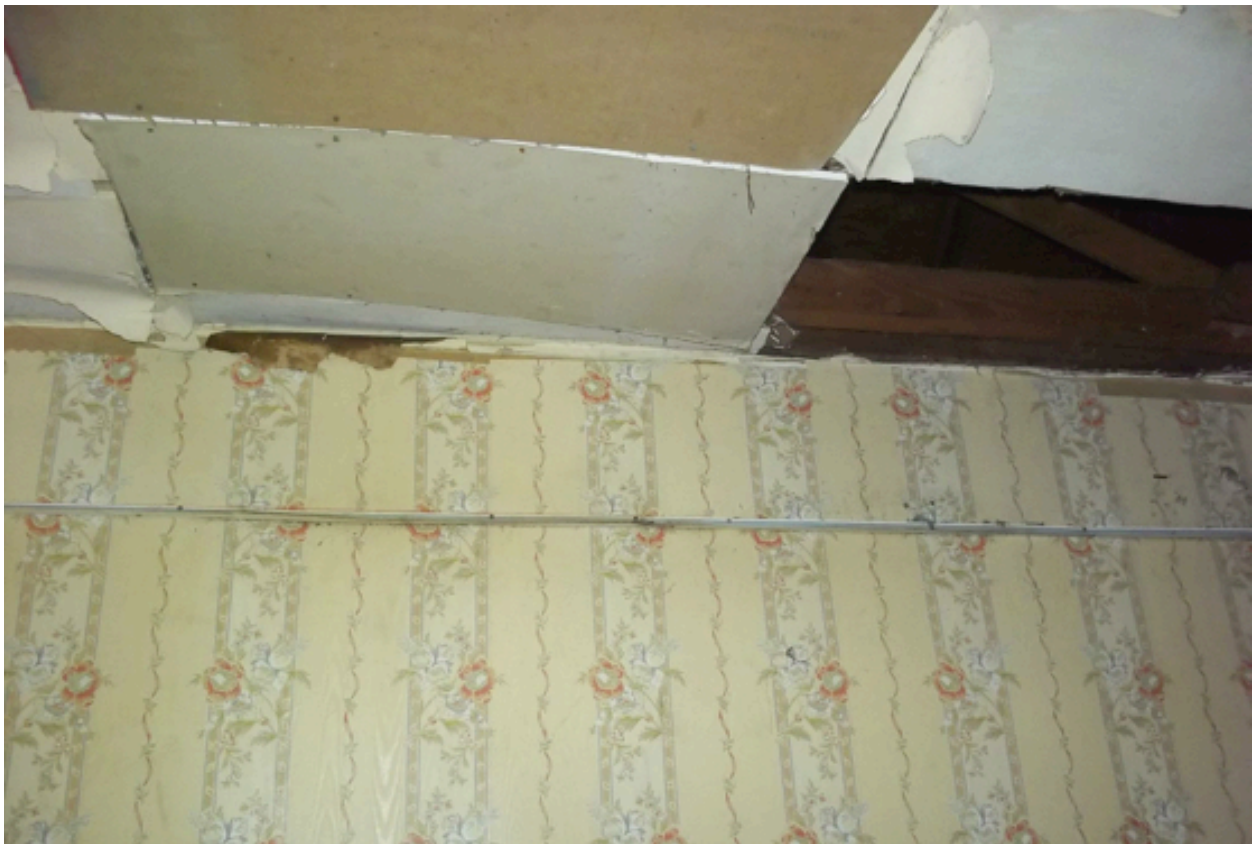
The ceiling measures 8’-1/4” high. Strips of bent metal are nailed approximately 1’ from the ceiling suggesting a drop ceiling was installed during the twentieth century after the wallpaper was installed (Figure 3.108). The ceiling in this room has moisture damage and a large hole has been cut into it. Though no damage to the surrounding walls and flooring is evident, it does create an entry for rodent habitation and water damage to occur.

Figure 3.108: Evidence of drop ceiling from the bent metal strips attached to the wall.

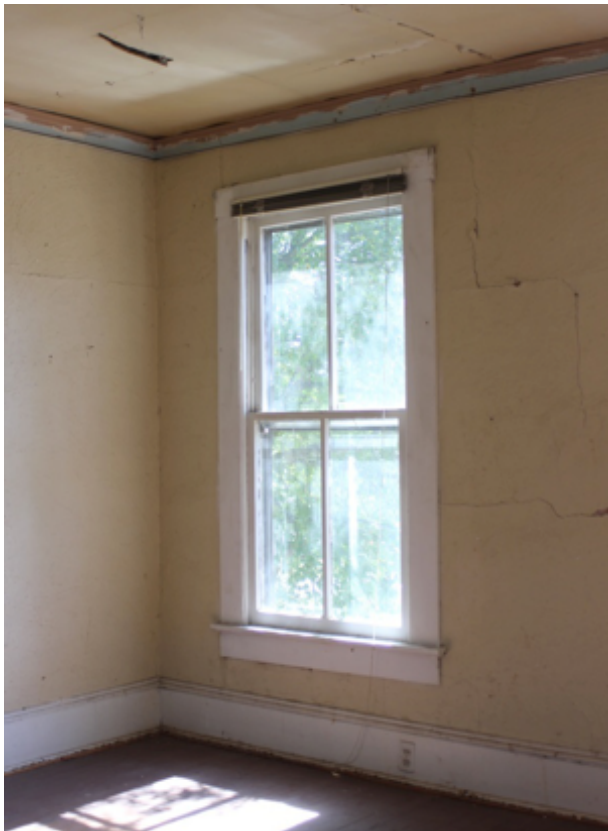
Figure 3.112: Southeast corner of Room 206. This image depicts the 2/2 double hung window details, the wood floor, baseboard and removed picture molding. Note the damage to the ceiling and walls.

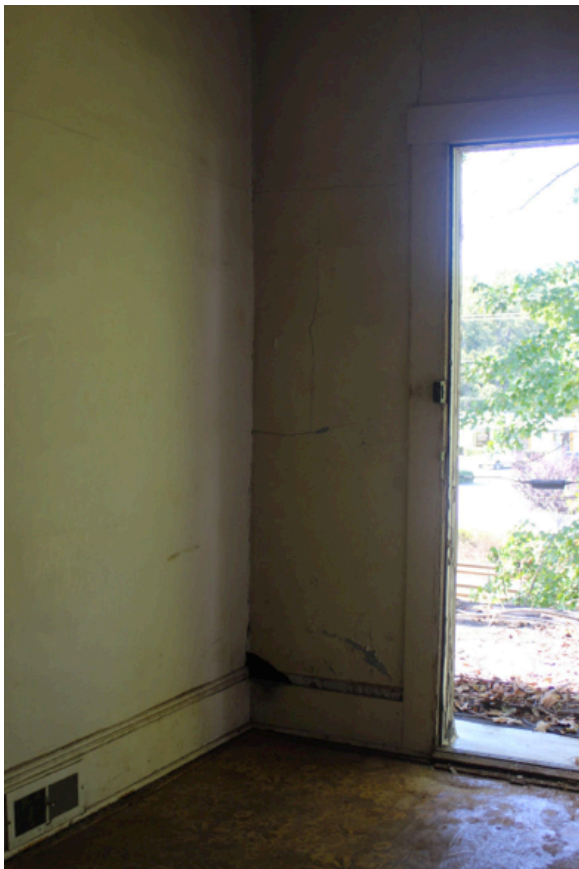
Figure 3.113: Southwest corner of room 207 showing west door entering to roof. Note the holes in the drywall in the bottom southwest corner.

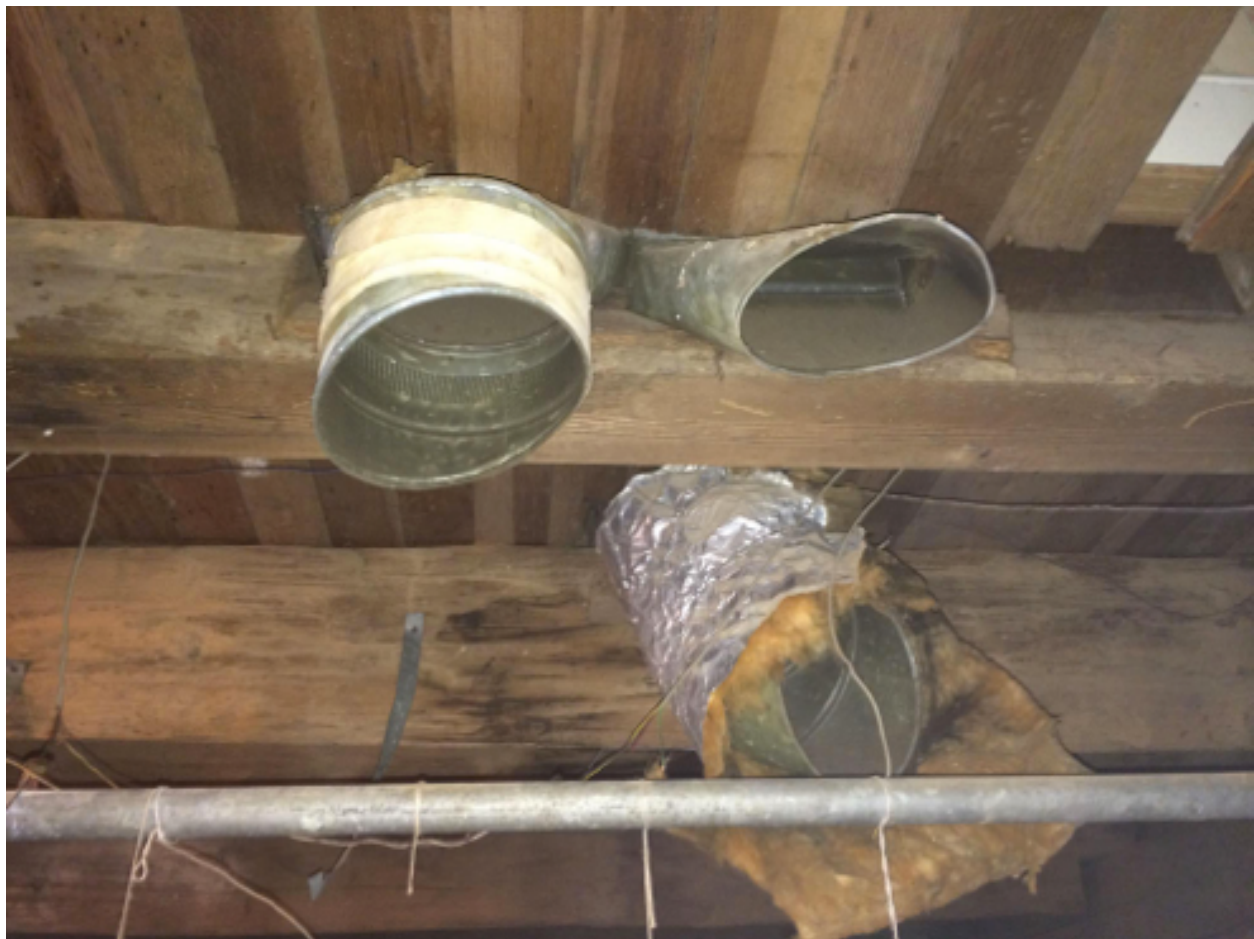
The HVAC system has been removed. The remaining evidence of the HVAC consists of, remaining duct works in the crawl space, one large return vent in room 101, and some smaller, supply vents in the remaining rooms (Figure 3.116). None of the vents are attached to any ductwork. There is a concrete pad on the south side of the house where the condenser unit would have been located, as well as a hole in the masonry-foundation wall that would have served as an entrance for coolant lines. Portions of the ductwork system remains are located in the crawl space in the basement but they do not serve a function.

Figure 3.116: HVAC vents no longer in use underneath room 101 and 108.

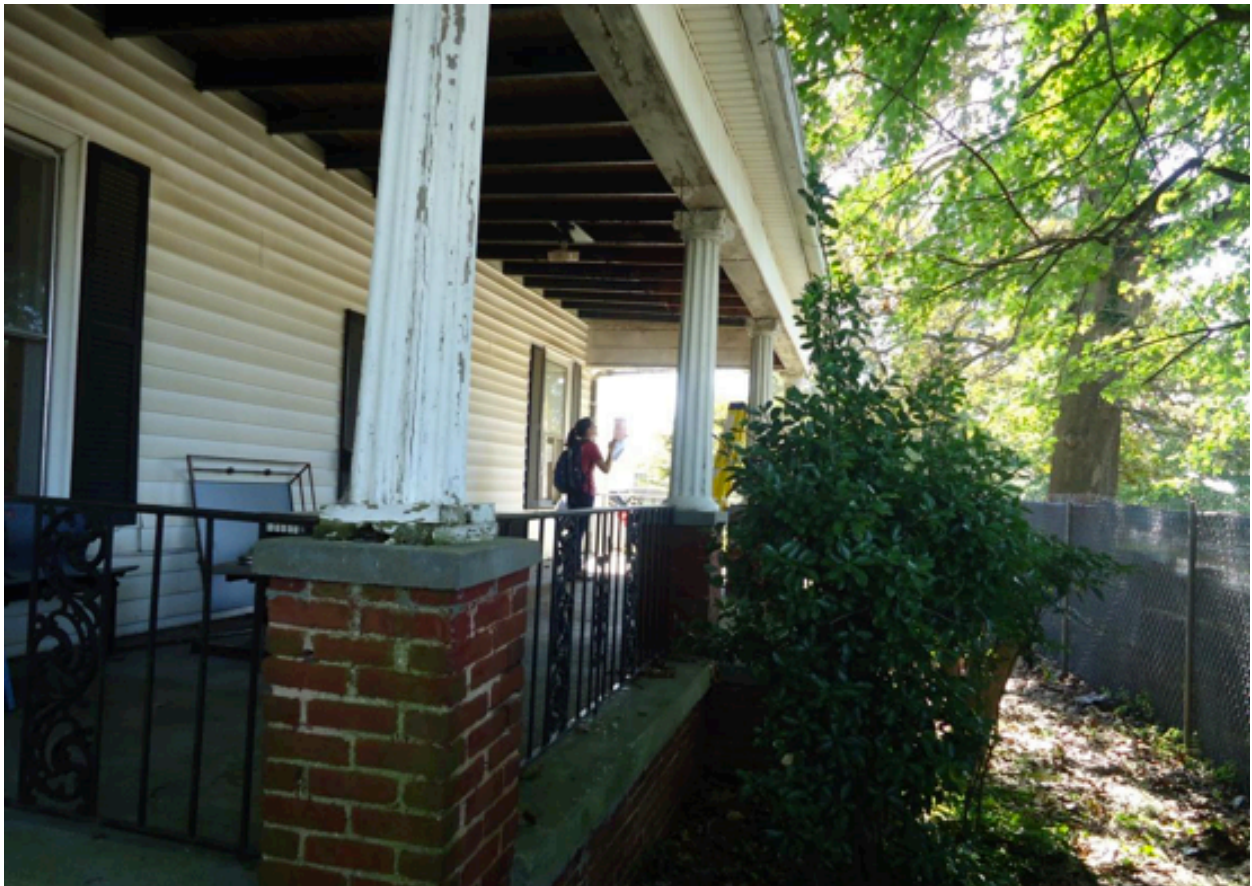
The shrubs that flank the entrance to the house from Dixie Avenue as well as the front porch on the western façade, are overgrown and in need of pruning. Shrubs on the north side of the house shown in Figure 4.4 are overgrown and too close to the structure putting the siding, windows, and foundation material at risk

Figure 4.3: North facade of the Moore House.

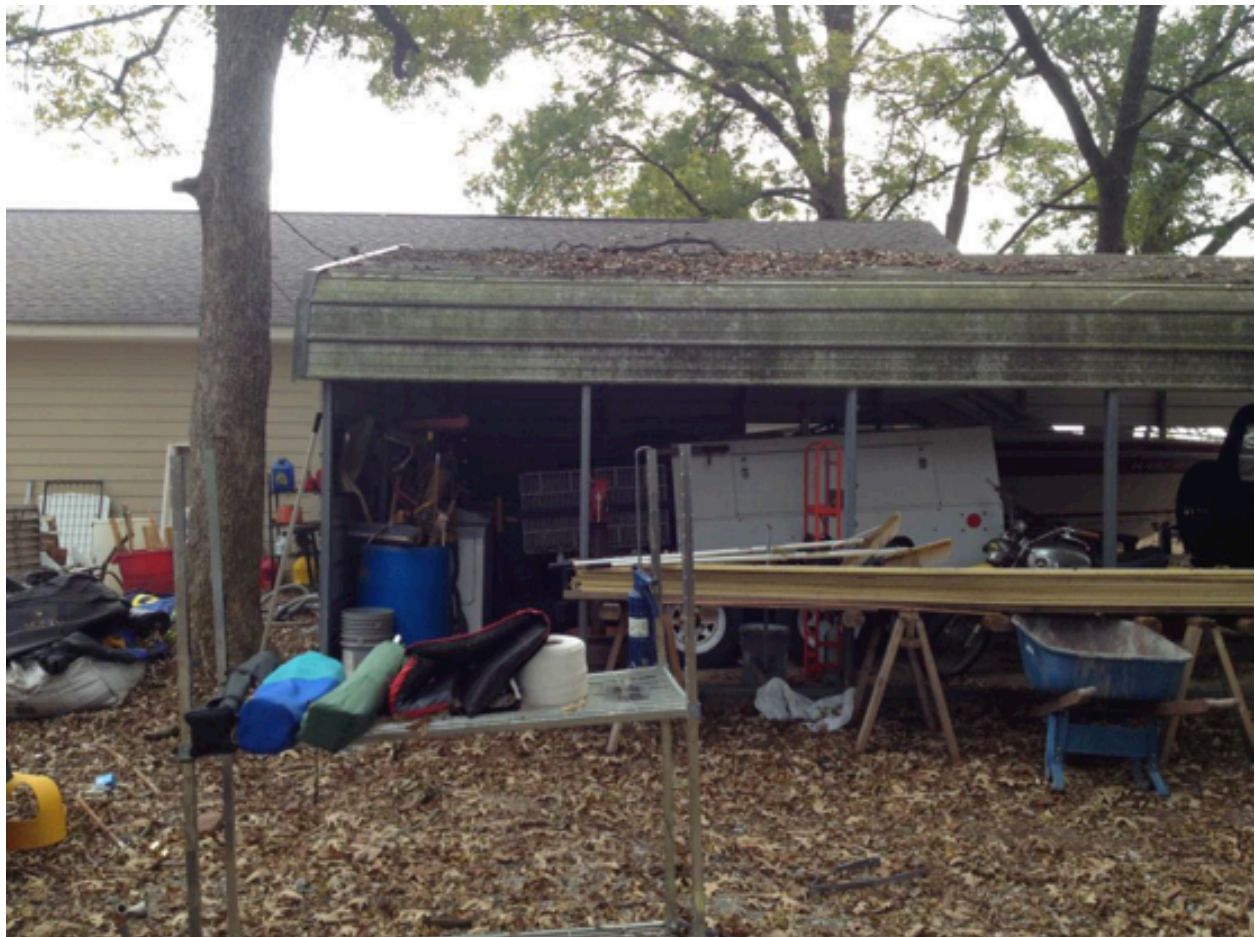
The non-historic carport is in good condition though there is a significant amount of leaves and dead tree limbs that have been deposited on the roof by the trees above as shown in Figure 4.6. Because the carport and the office are beneath several trees that line the eastern border of the property, the likeliness of natural debris falling on or around the structure and causing future damage is high. Since most of the carport is not covered, there is a potential risk that high winds could blow the loose material surrounding the carport underneath the roof or through gaps in the structure, thus damaging its valuable contents as shown in Figure 4.7.

Figure 4.6: North side of carport.
